REMEDIAL INVESTIGATION/FEASIBILITY STUDY
REPORT

INSTALLATION RESTORATION
PROGRAM (IRP) REMEDIAL
INVESTIGATION/FEASIBILITY STUDY

KOTZEBUE LONG RANGE
RADAR STATION, ALASKA

JULY 1995

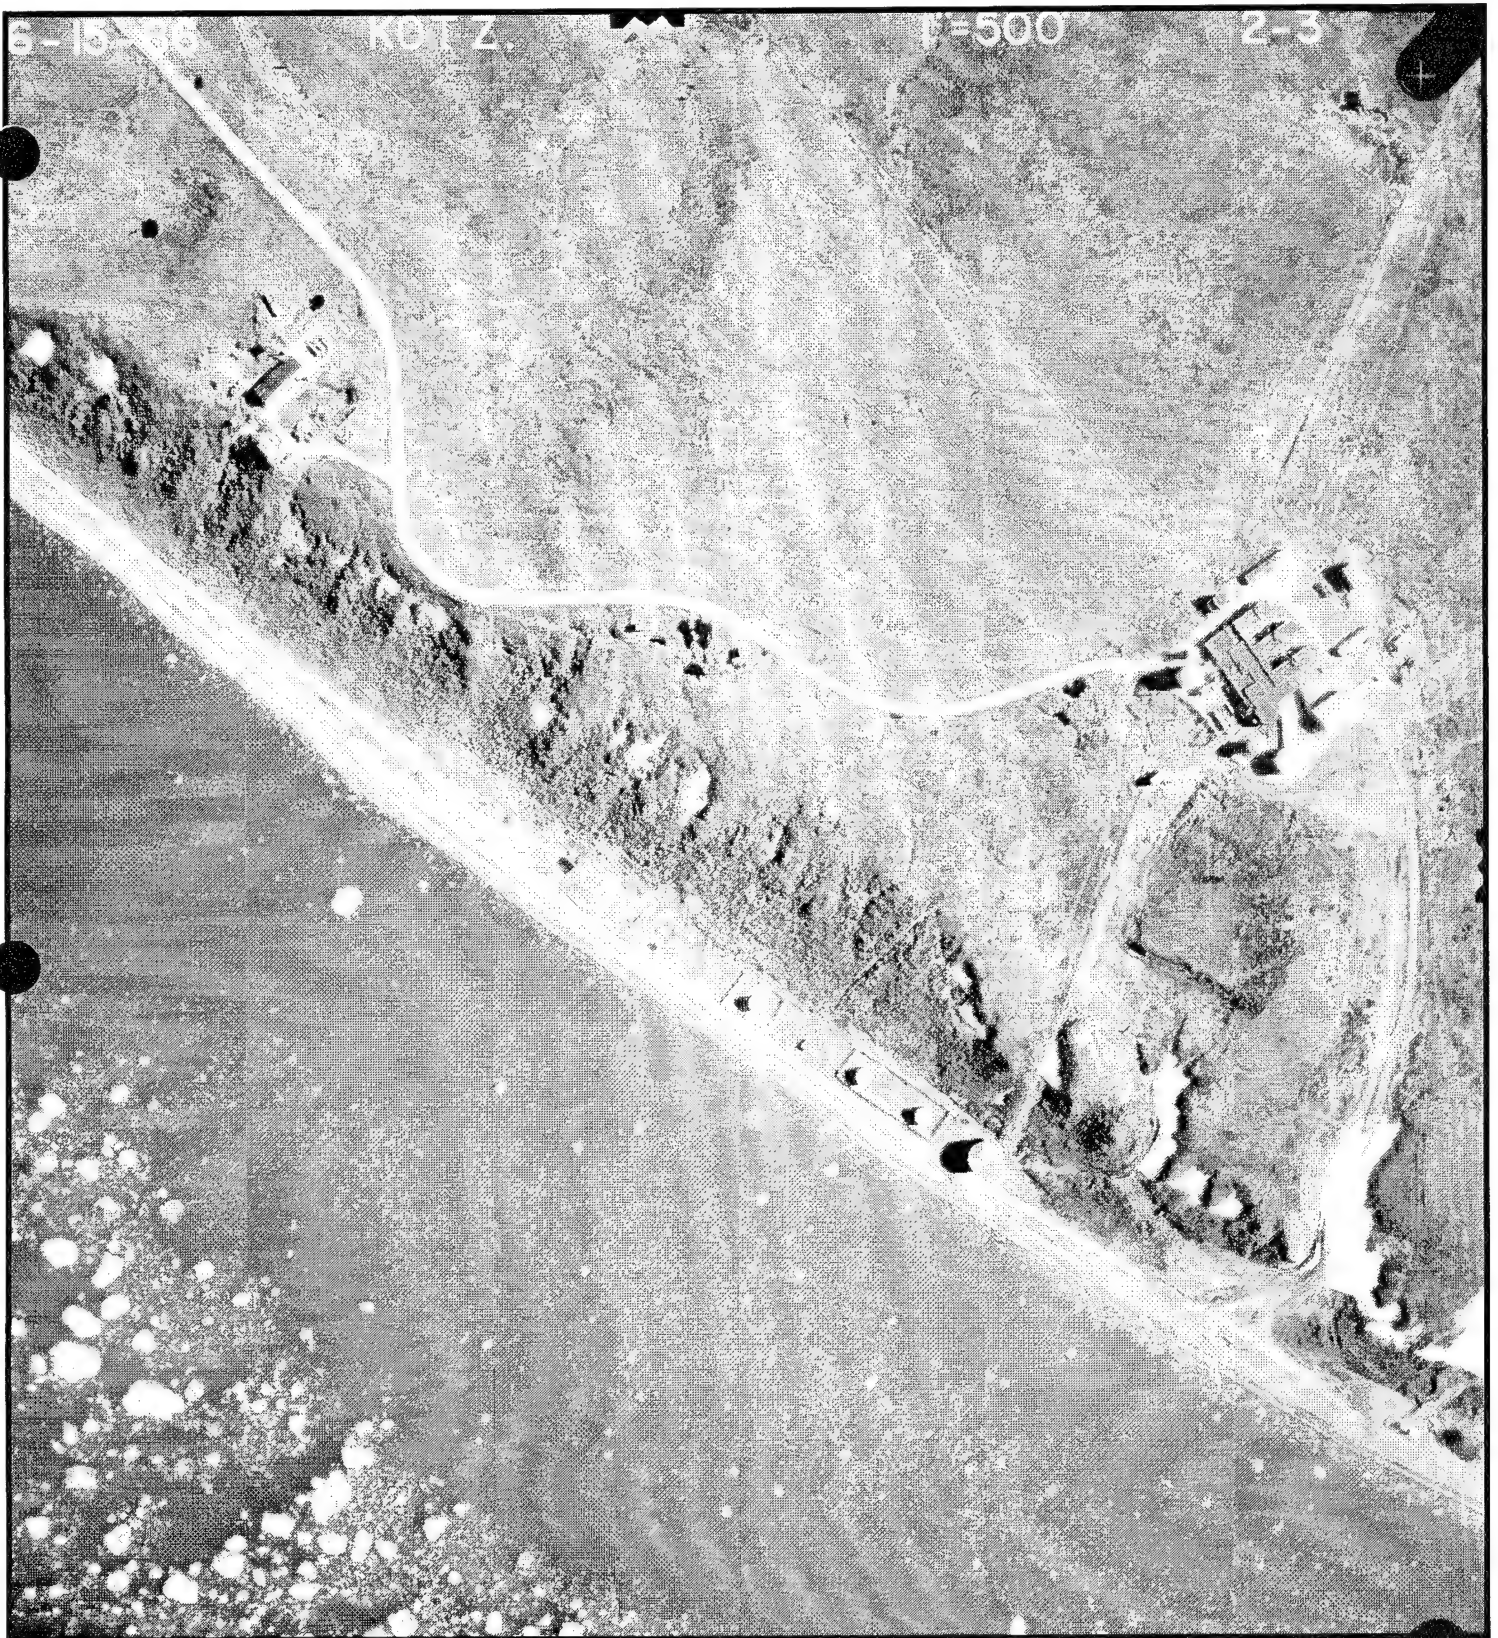
Figure 2-1. 1986 Aerial Photograph of Kotzebue LRRS (reproduction).

Kotzebue LRRS is located on the Baldwin Peninsula, a marine spit that extends into Kotzebue Sound. The Baldwin Peninsula lies within the Kobuk-Selawik Lowland section of Coastal Western Alaska (see Figure 1-1). This region is characterized by broad river floodplains and lowlands, forming deltas along their seaward margins. The ground surface is composed of moist tundra vegetation, with wet silts and permafrost underlying most of the area (USAF 1990a). Figure 2-1 is a reproduction of a 1986 aerial photograph of Kotzebue LRRS showing general site features. Figure 2-2 is a reproduction of a 1980 aerial photograph of the Kotzebue area, showing the City of Kotzebue in relation to the site.
